OPERATION
BREAKTHROUGH

U.S. Department of
Housing and Urban
Development

A COMPENDIUM
OF THE PERFORMANCE
TESTING PROGRAM

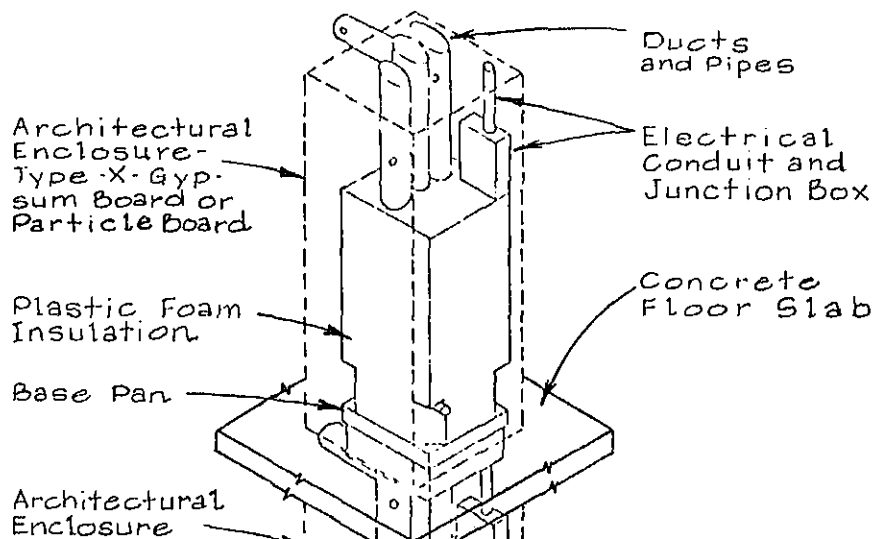
1. Passage of fire between floors through a mechanical/electrical core installed in a tall building. (See fig. 3.)

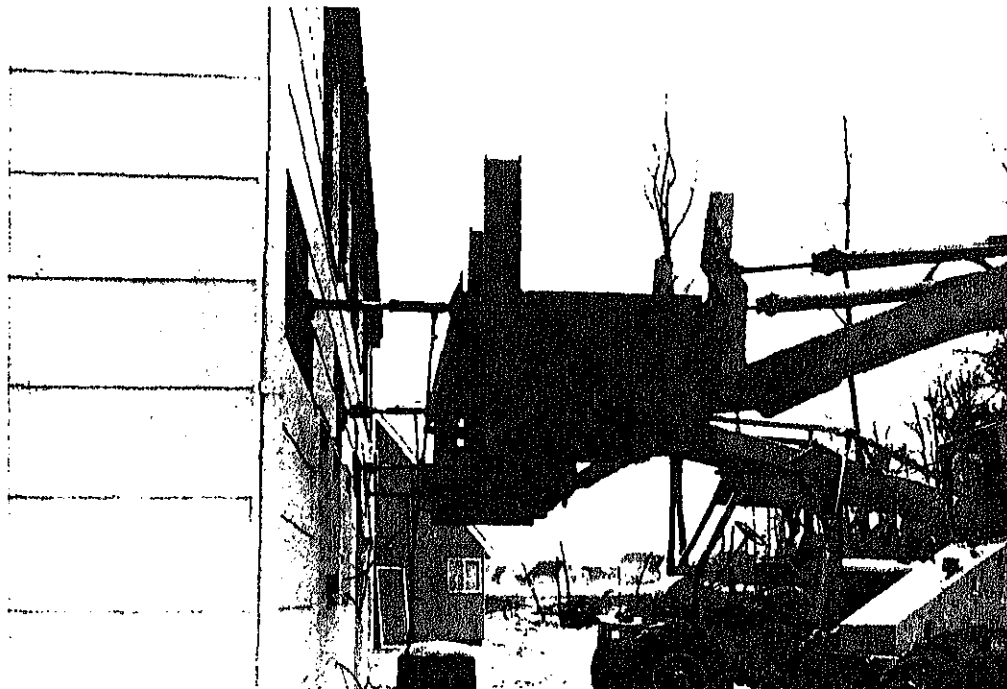
The test house was a two story, basement-less, single family dwelling in a typical suburban residential development. Loads were applied by hydraulic jacks pushing against the house at four points and reacting against two fork lift trucks weighted with large concrete blocks. (See fig. 6.) An impulse load was obtained by sudden removal of one of the forces. Static (simulated wind) loads were applied at both the second floor and roof levels and displacements measured with electronic devices.

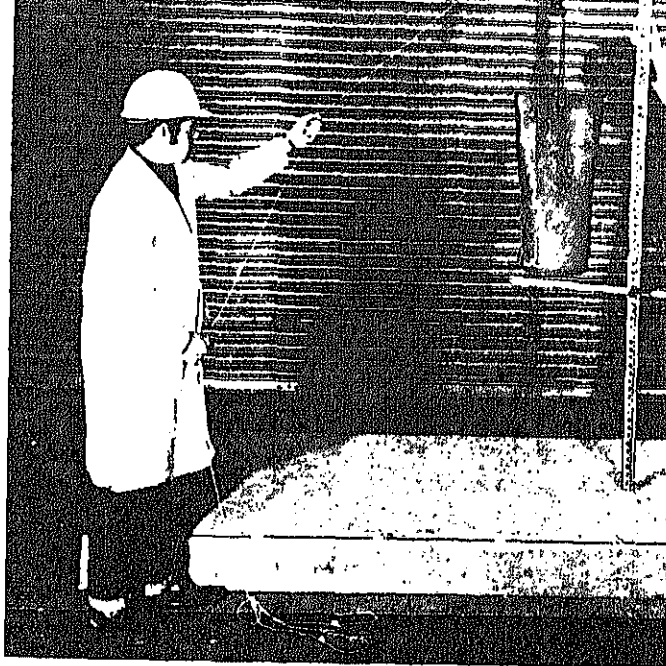
FIGURE 7
APPARATUS FOR APPLYING IMPACT LOADS TO WOOD JOIST FLOORS

consisted of impact loads (see fig. 7) of increasing magnitude alternating with static loads of a fixed magnitude being applied to the test specimens. Deflection measurements indicated that the deflection caused by a given concentrated load increases as the impact energy previously applied to the floor increases.

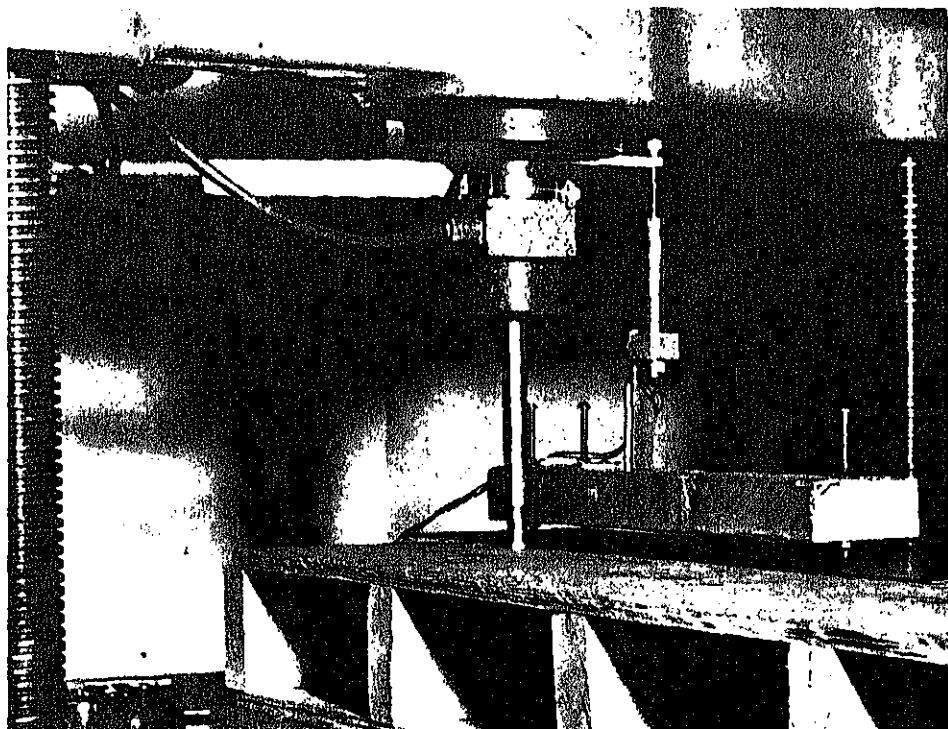
the laboratory floor, the test results were primarily concerned with properties of the flooring surface and did not take into account the possible effects of joist deflection. (See fig. 8.)

Loads were applied at several locations on each panel, including over the joists and at free edges. Testing techniques differed from ASTM E 72 [13] for the structural strength of a system and ASTM D 2911 [14] for finished flooring, since it was determined that these were not applicable to floor systems with thin skins. Loaded areas had diameters of one inch, 5/8 inch, and in a few cases, 1/2 inch were used. Most test applications were taken directly to failure, although in some cases loads were removed and reapplied with an increased magnitude.

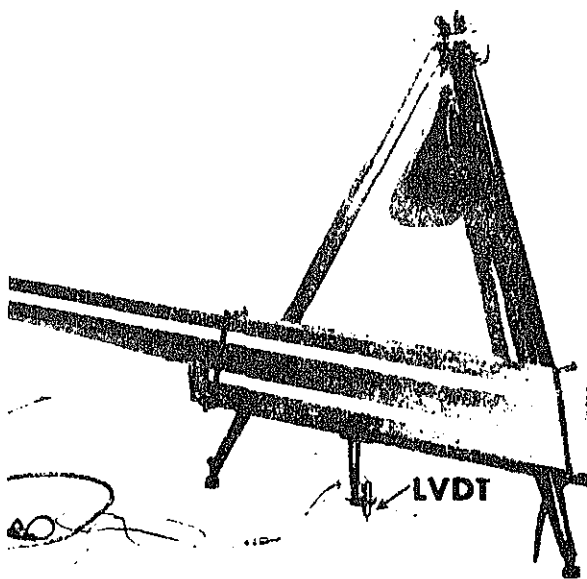
FIGURE 9
APPARATUS FOR
INDUCING TRANSIENT VIBRATIONS

Testing was carried out in a total of 34 rooms in seven completed prototype dwelling units—four furnished and three unfurnished. A load was applied by drop-

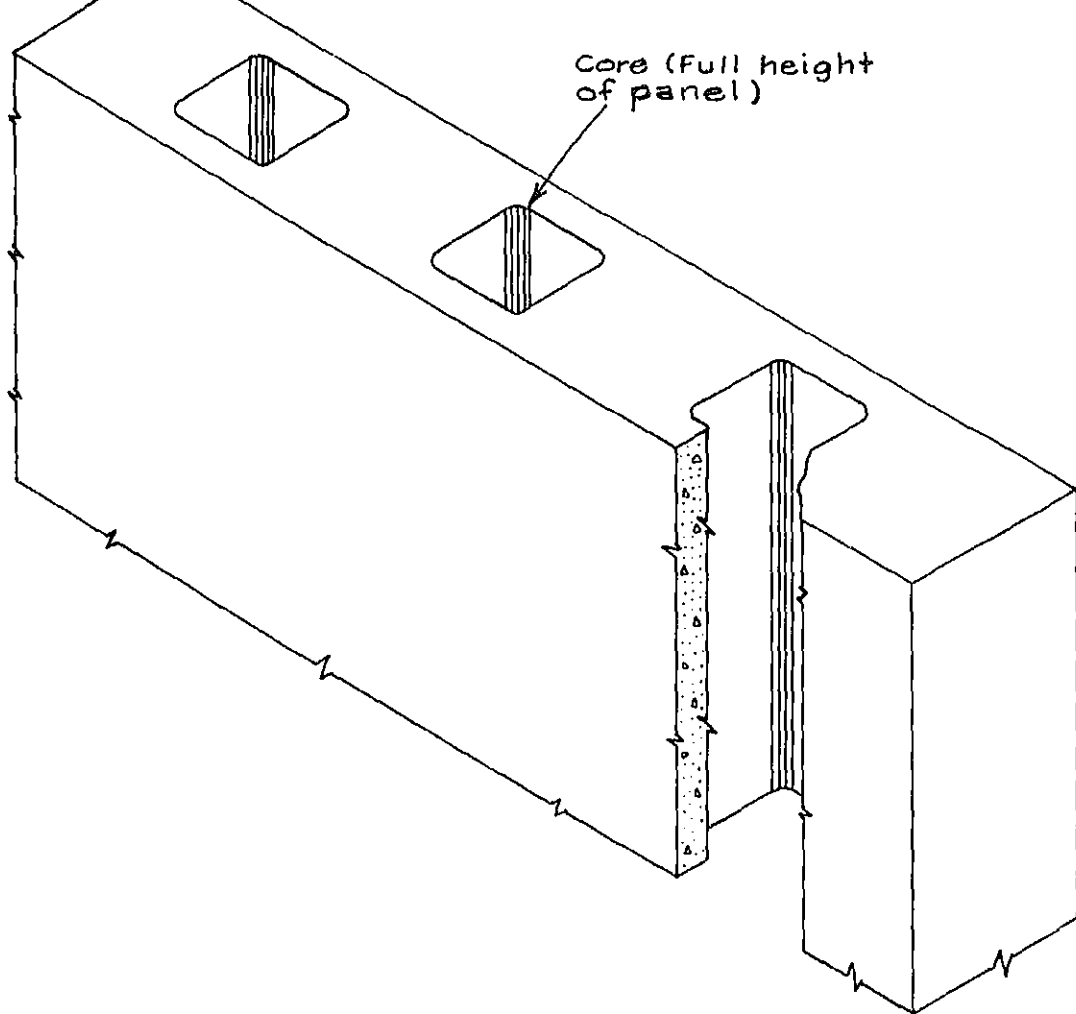
FIGURE 11
HOLLOW CORE PRECAST WALL PANEL USED IN CONCRETE BUILDING SYSTEM

One of the Operation BREAKTHROUGH systems used hollow core precast concrete wall panels. When these were erected they served as supports for thin prestressed concrete slabs. The slabs in turn served as a form for

cast in place concrete topping to produce a composite floor or roof. Depending on conditions, some or all of the wall panel cores were filled with cast in place concrete.

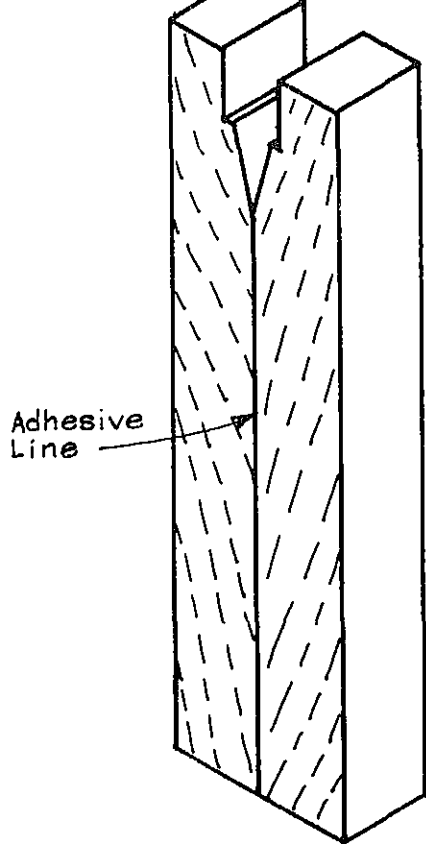
FIGURE 12
CLEAVAGE SPECIMEN
FOR TESTING ADHESIVES

tant that there be knowledge as to their strength, reliability, and durability. Because of the lack of time for a lengthy study, a series of short term tests was devised to assess the long term load carrying capacity of proposed adhesives under adverse conditions.

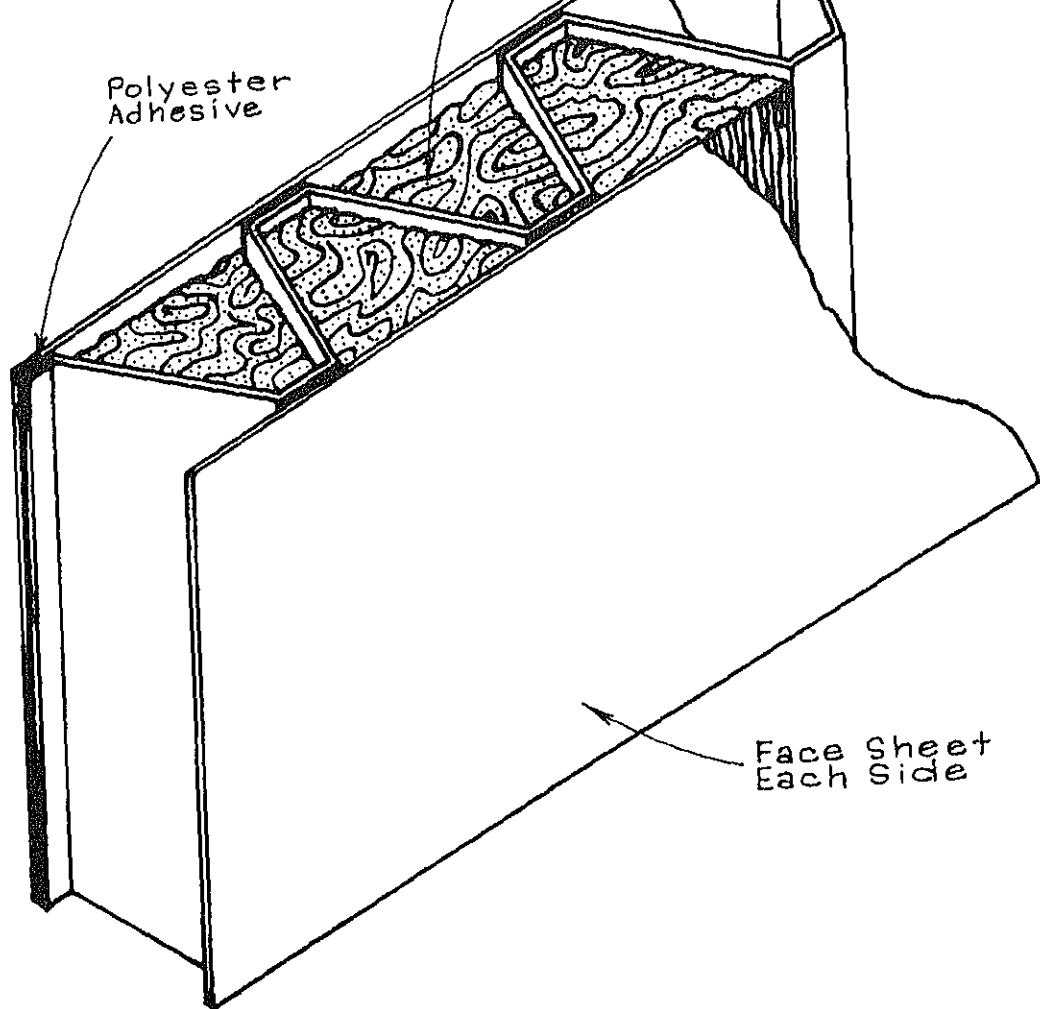
FIGURE 13
FIBERGLASS REINFORCED POLYESTER SANDWICH PANEL

An innovative structural system employed by one Operation BREAKTHROUGH HSP used a plastic laminate assembly in walls, roofs, and interior partitions. The basic

The innovative panel described in section 3.3.2 and shown in figure 13 also required testing to determine its structural properties. The sheets themselves were an innovative building material, the strength of the adhesive joining them had to be evaluated (some study of this was made in the tests reported in section 3.3.1), and the behavior of the assembly, while it could be calculated, had to be verified experimentally. The effects of moisture and temperature on the behavior of the panel material also required investigation. This test program was undertaken to study all these features.

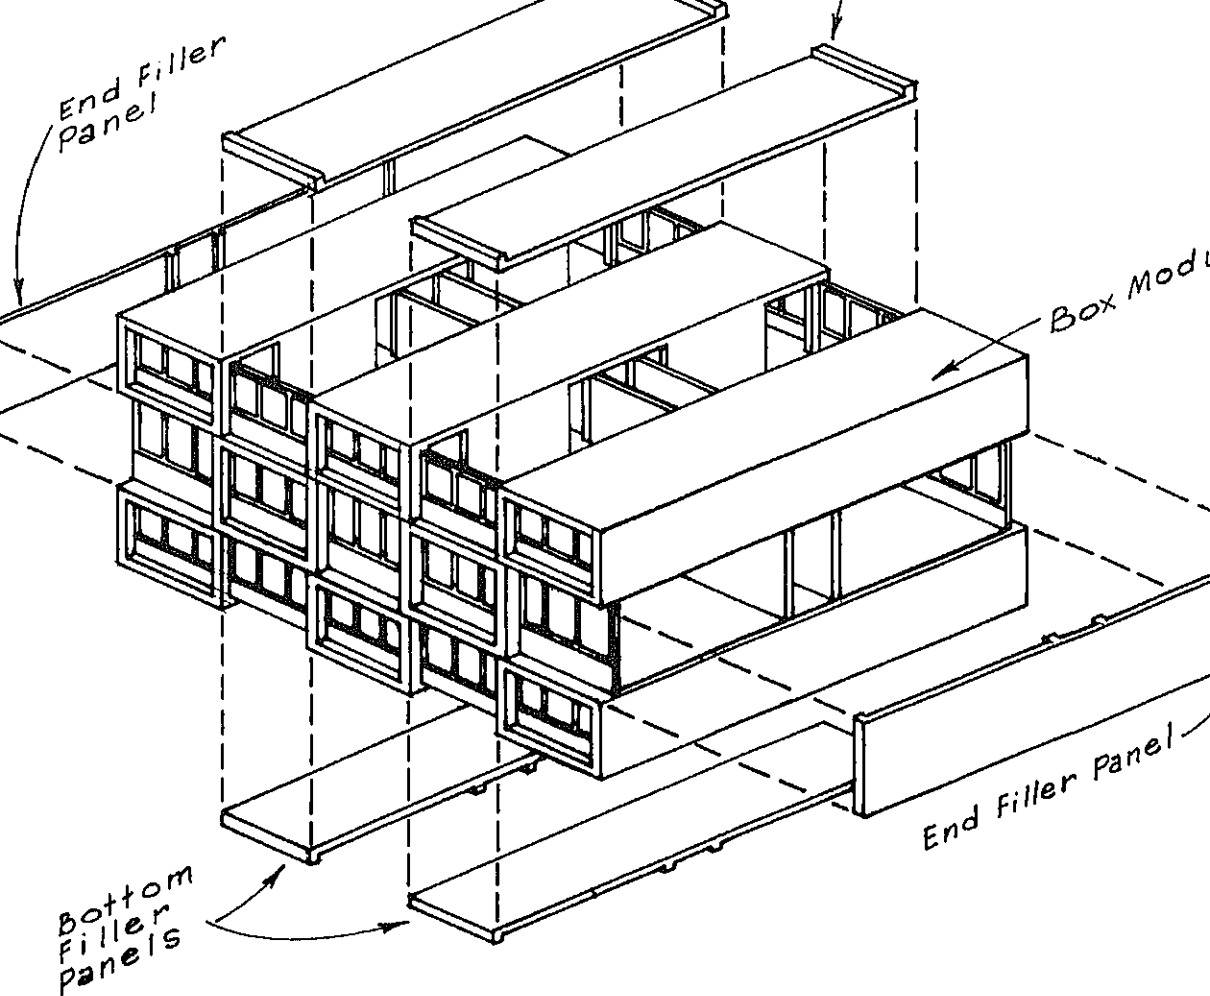
FIGURE 14
ASSEMBLY OF PRECAST UNITS IN CONCRETE MODULAR HOUSING SYSTEM

Innovative construction details require special consideration particularly when they involve materials whose properties are not well known or whose interaction has not been investigated. This program was carried out to study the behavior and strength of a column connection system used between prefabricated housing modules.

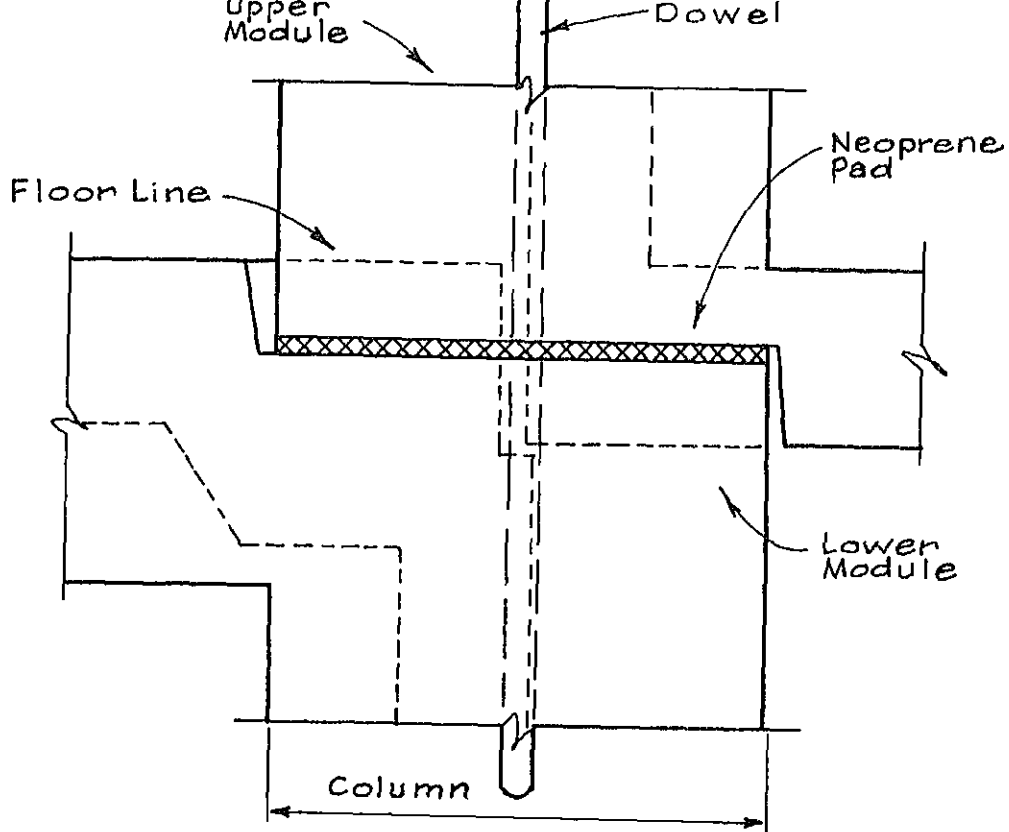
FIGURE 15
DETAIL OF COLUMN CONNECTION IN PRECAST CONCRETE BOX HOUSING SYSTEM

transmitted from the columns of one module to those of the module immediately below through neoprene pads. Compressive bearing stresses were considerably higher than those normally used with neoprene. Resistance to any uplift and also to horizontal shear was provided by a grouted dowel crossing the horizontal joint. (See fig. 15.)

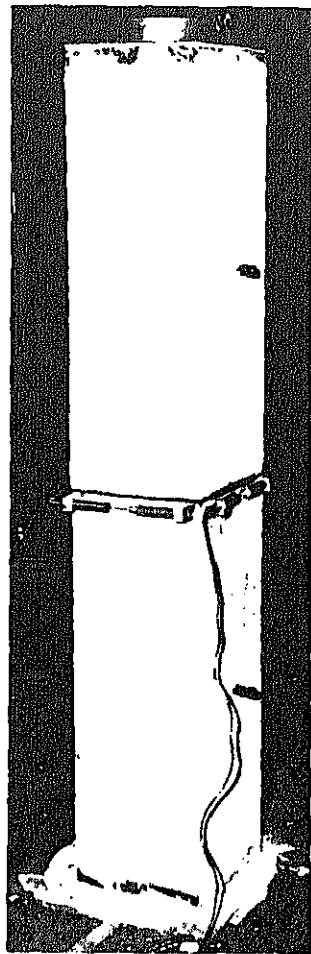
FIGURE 16
SHORT COLUMN SECTION
USED TO TEST JOINTS IN PRECAST
CONCRETE HOUSING SYSTEM

Three short column sections were assembled end to end with neoprene and with steel-neoprene joints. An axial compression was applied by a loading yoke. The center section was pushed down by a testing machine while the end sections were restrained. In some tests the direction of loading was reversed cyclically. (See figs. 18 and 19.) Test results provided the

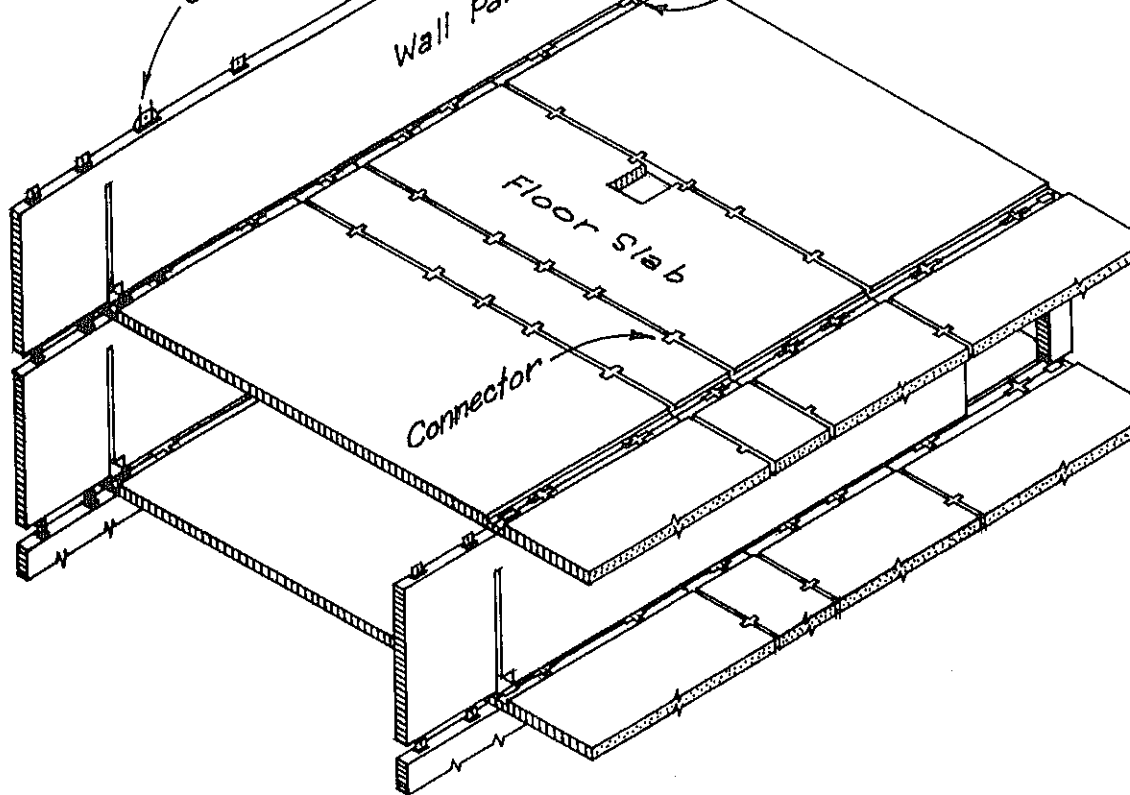
FIGURE 20
ASSEMBLY OF UNITS IN PRECAST CONCRETE PANEL HOUSING SYSTEM

One Operation BREAKTHROUGH system to which this applied used large precast concrete wall, floor, and roof panels with bolted steel interpanel connecting elements. These elements were very important because they furnished the primary structural connection between the panels and were designed not only for the transfer of static loads but also of wind and seismic loads that were to be carried through the floor diaphragms to shear walls. (See fig. 20.) Since there was no standard test for the features to be investigated, methods were devised to simulate the loadings for which the system was designed. Small sections of finished, full size concrete elements were used as test specimens during simulated loading. Electronic instrumentation was used to measure and record loads and deformations.

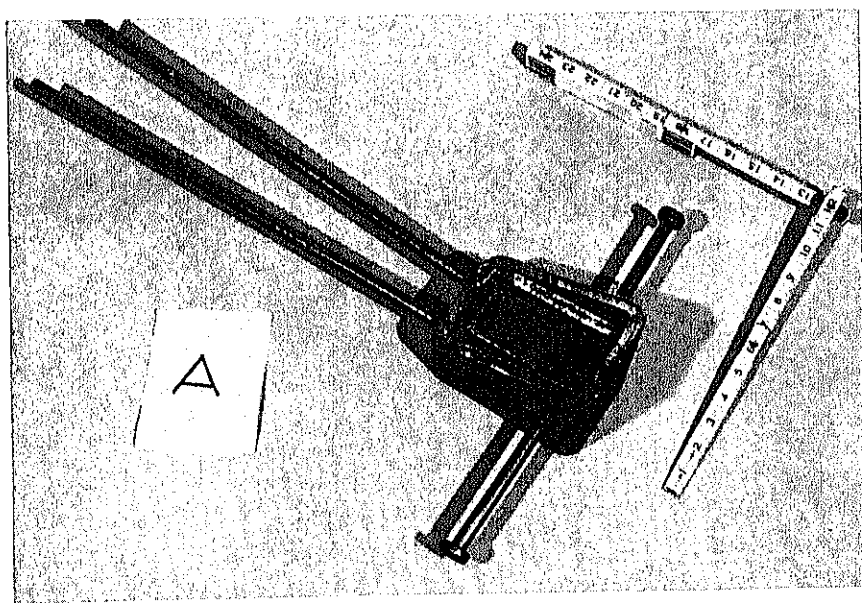
floor slabs met over a bearing wall. These connections were tested by applying tensile loads with jacking frames and measuring the resistance of the anchorage to being pulled from the concrete in which it was embedded. (See fig. 22.)

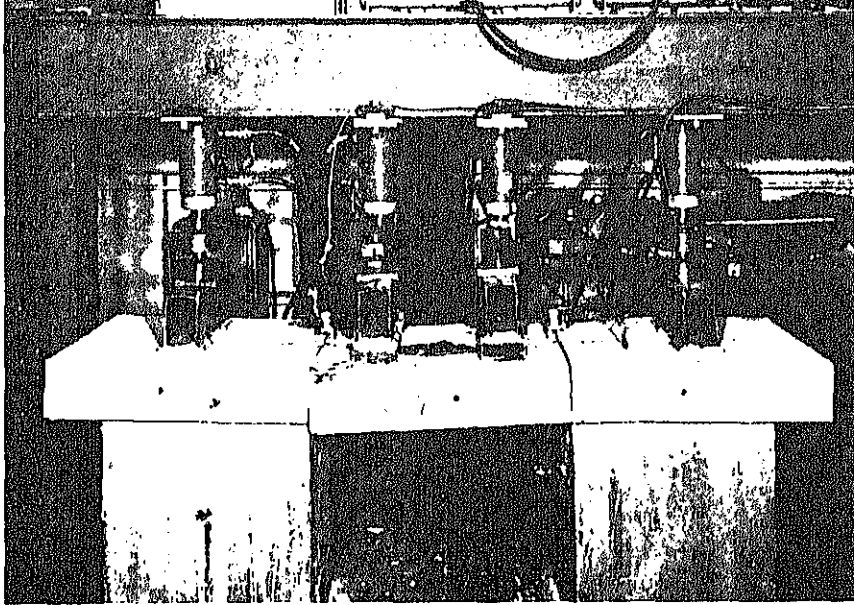
FIGURE 24
TESTING HOUSING SYSTEM INSERT SHOWN IN FIG. 23 (VERTICAL SHEAR)

Type B connections (see fig. 23) were located at the edges of the floor slabs and were used to join one slab to another or to a longitudinal shear wall. They were required to transmit vertical shear (across the plane of the slab) and horizontal shear (in the plane of the slab). The first condition can occur when one slab is loaded differently from the other, or when the connection element is used to align an out of level slab. The other condition can occur when the floor diaphragm carries wind or seismic forces in the horizontal plane. The friction connection between abutting connecting elements was made with high strength bolts in oversized holes.

The first test, on the Type B element, measured tensile pull out resistance by a method similar to that used with Type A connections. Vertical (out of plane) shear tests were conducted on specimens constructed to represent portions of three side by side slabs joined at their edges by Type B connectors. The center slab was pushed down while the others were restrained. (See fig. 24.) Similar specimens were used for investigation of horizontal (in plane) shear resistance. They were tested with the slabs in a vertical plane; the outer slabs were supported near the juncture with the center slab so as to minimize rotation and produce as closely as possible a pure shear loading condition. (See fig. 25.) When the center slab was pushed down, the vertical force was resisted by friction at the interfaces until slip occurred. Ultimate failure during this

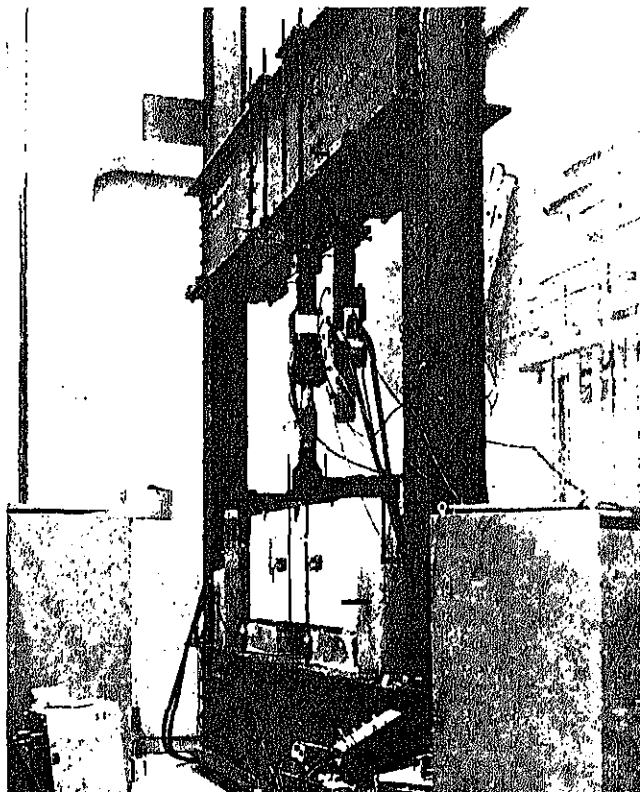
FIGURE 26
TYPE D INSERT USED IN A CONCRETE HOUSING SYSTEM

Type D wall connectors (see fig. 26) were used, in conjunction with Type A, to join floor slabs and bearing walls. Because of the Guide Criteria recommendations for prevention of progressive collapse, the ability of the Type D connectors to resist shear forces acting perpendicular to the face of the wall was critical. The test specimen for the Type D element was in the form of an H, with the wall panel as the crossbar. Concrete members representing the floor slabs formed the verticals. Load was applied to the wall near the face of the slabs. Failure occurred when the connection started to shear through the concrete.

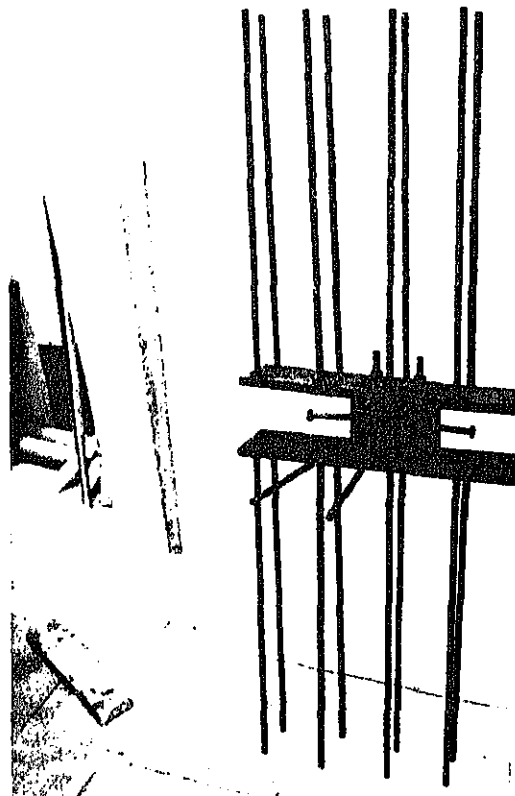
FIGURE 28
TESTING TYPE E INSERT
USED IN CONCRETE HOUSING SYSTEM

load was applied to the bolts at the top of the connector (see fig. 28), whereas in testing the Type F connector, the load was applied to bolts simulating those from a Type E connector. (See fig. 29.) Failure occurred either by breaking the bolts or stripping the threads.

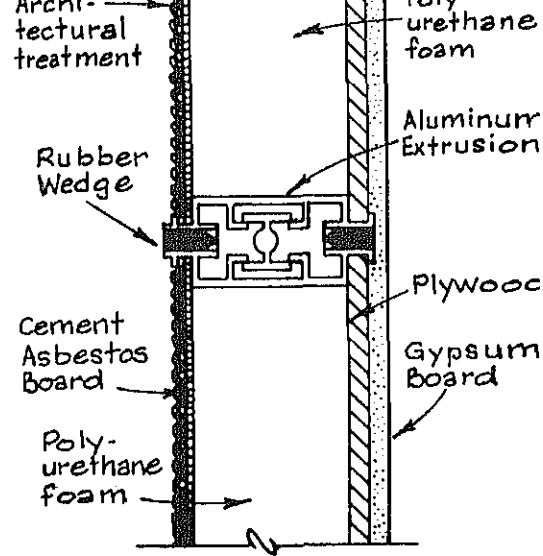
FIGURE 31
POLYURETHANE CORE SANDWICH PANEL

Three series of tests were performed on full scale wall panels. They are believed to be realistic simulations of in use conditions and provided usable results. The first test series consisted of exposing the exterior facings of a pair of loaded panels to a 30

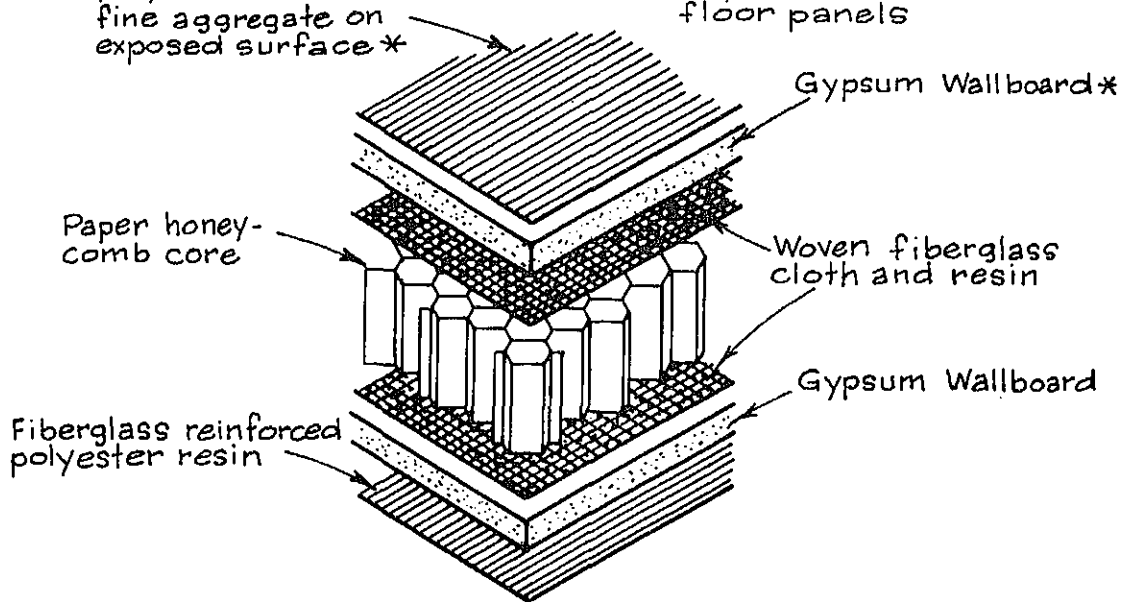
FIGURE 32
HONEYCOMB CORE PANEL WITH GYPSUM WALLBOARD FACING

One of the Operation BREAKTHROUGH systems employed innovative panels consisting of paper honeycomb cores faced with fiberglass cloth reinforced polyester resin for roof, wall, and floor members. This sandwich was the basic structural element for the entire housing unit. Both faces, except for floor panels, were covered with gypsum wallboard for physical and fire protection. Plywood was used as the upper (walking) surface of floor panels in place of gypsum board. Exposed surfaces of exterior wall panels were protected with

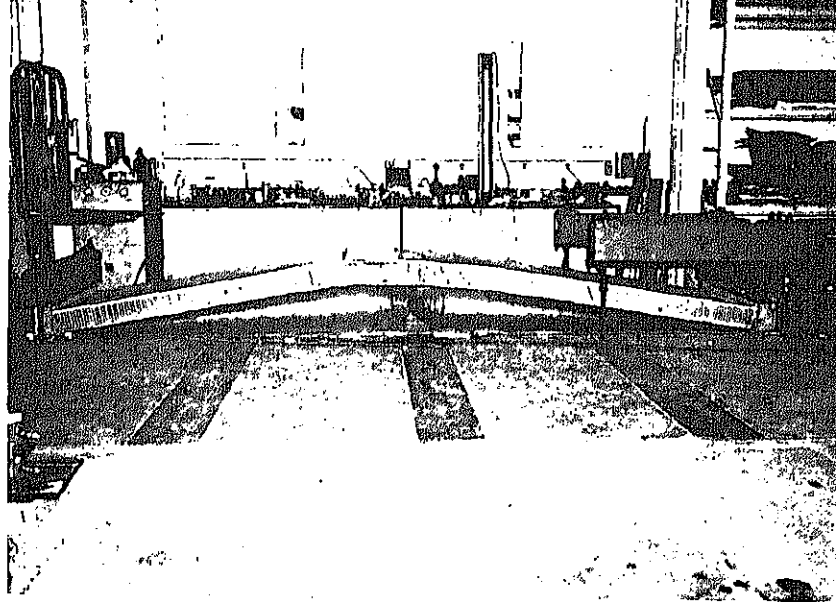
FIGURE 33
PANEL FLEXURE TEST
(IN INVERTED POSITION)

(See fig. 33.) Deflections were measured and recorded throughout the test. Results of this test showed that the ultimate capacity of the panels was about three times the service load, and that the behavior in flexure was quite elastic.

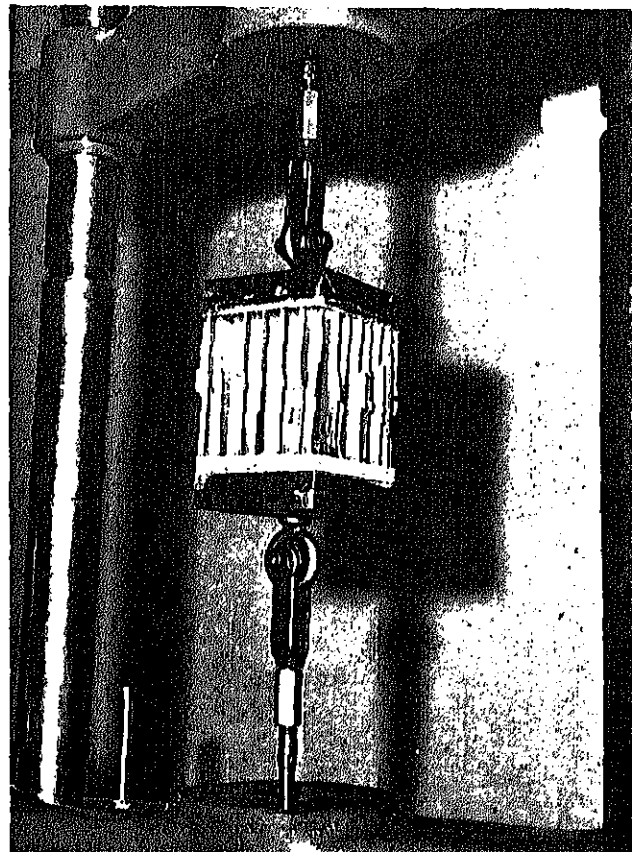
The strength of the bond between core and facing was measured on specimens cut from floor panels which had previously been tested for flexure. These specimens were loaded in direct tension in accordance with ASTM C 297 [32]. (See fig. 34.) Joint strength was tested in a special apparatus which incorporated a double acting hydraulic jack used to increase and decrease the angle between two connected members. Loading was applied in cycles until failure took place. The specimens

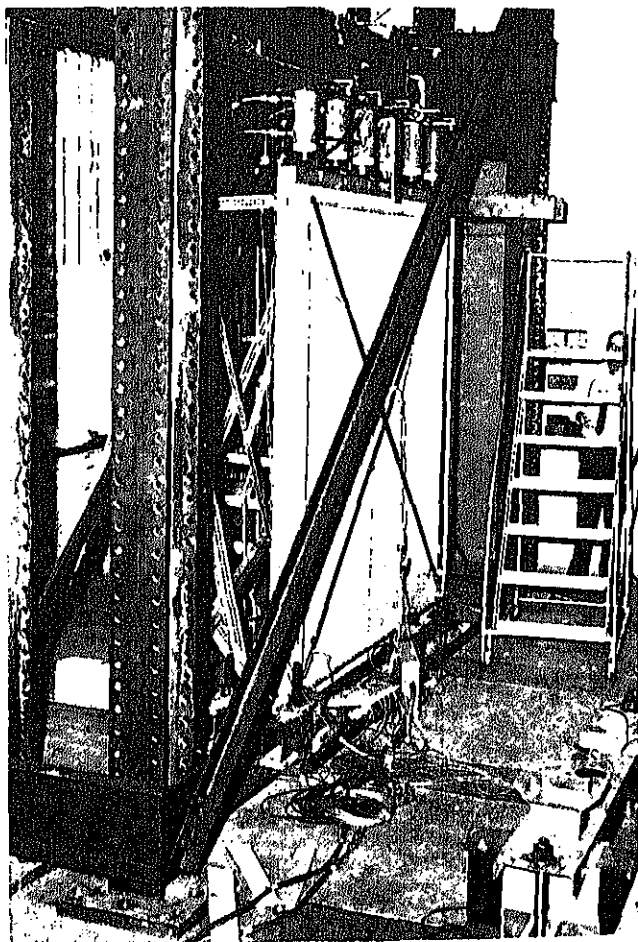
FIGURE 38

the laboratory floor. Racking loads were applied at an upper corner with a hydraulic ram. In the first test, no hold down was applied on the test specimen, in the second, a hold down force restrained the loaded corner; the third panel was tested with hold down forces distributed along its top edge. (See fig. 38.)

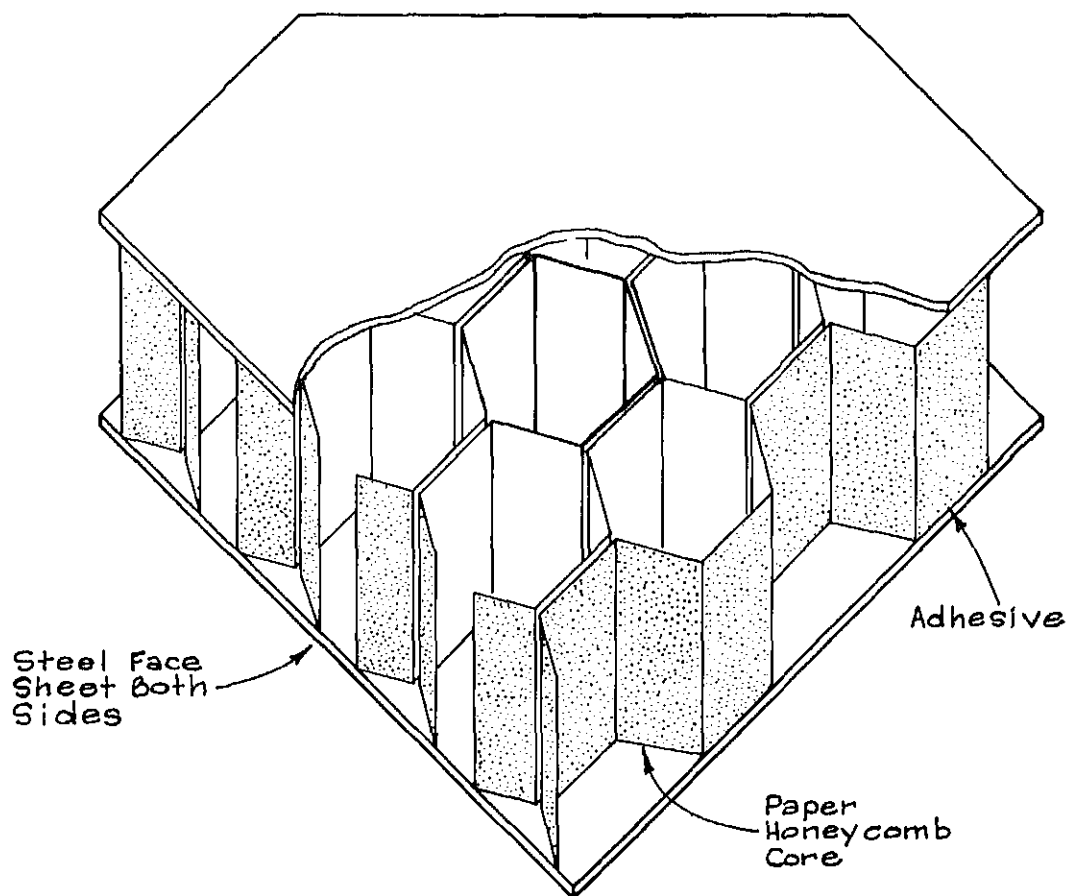
FIGURE 40
FLEXURAL TEST OF STEEL FACED SANDWICH PANEL

properties of the component materials as well as the completed panels. (See fig. 40.)

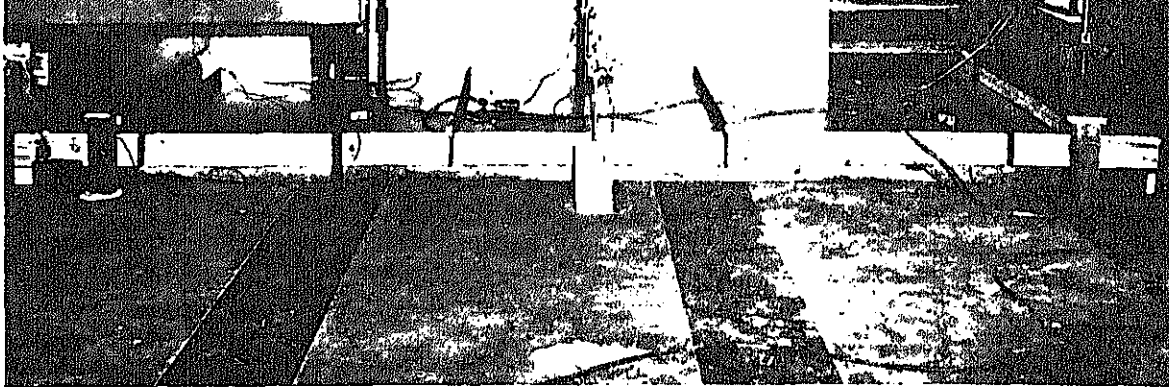
Since it was intended that no additional roofing membrane be used, the long term strength of the roof panel was of particular importance. For this reason, tests were made on roof panels rather than panels intended for use in walls and floors. The test program was designed to study the

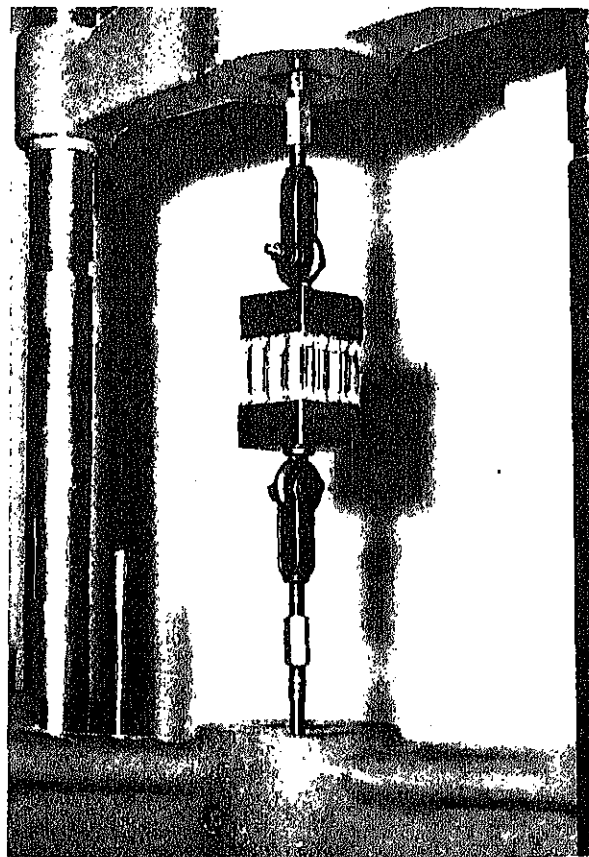
FIGURE 41

Tensile strength tests were conducted on panels, in a direction perpendicular to their facings, to determine either the strength of the honeycomb core or the strength of the adhesive bond joining it to the metal facings, depending on which was weaker. These tests were carried out in accordance with ASTM C 297 both before and after accelerated aging in accordance with ASTM C 481. (See fig. 41.)

The results of the accelerated aging indicated that one type of adhesive proposed for use in the sandwich panels was unsatisfactory because of its water solubility. The other adhesives tested appeared satisfactory after the aging tests but the coefficient of variability computed for the strength of the panel material was rather high (0.41).

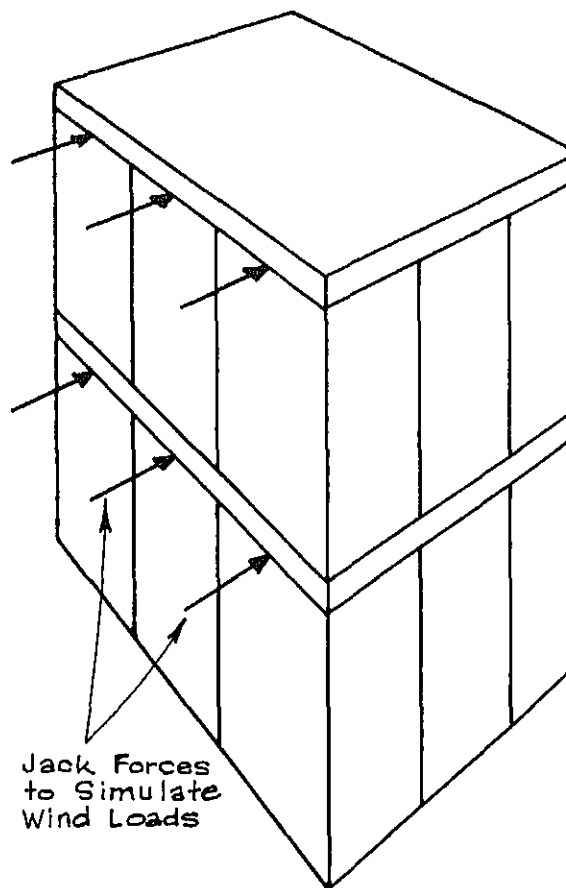
Operation BREAKTHROUGH HSP. Because of its highly innovative nature there were questions as to the ability of the panels and connections to provide adequate resistance to lateral forces and to maintain the drift limits recommended by the Guide Criteria under both design load and required ultimate load. This test was made to study the effects of simulated wind loading on a small two story housing module, which was 12 ft square and constructed and anchored in accordance with the HSP's standard details. (See fig. 43.)

tion system were used to apply a load to the side of the module. Two different loads were applied during the test. In the first load cycle, a force corresponding to 100 percent of the design wind load was used; in the second, loading was increased until failure occurred in the spline connection between the panels at 130 percent of the design wind load.

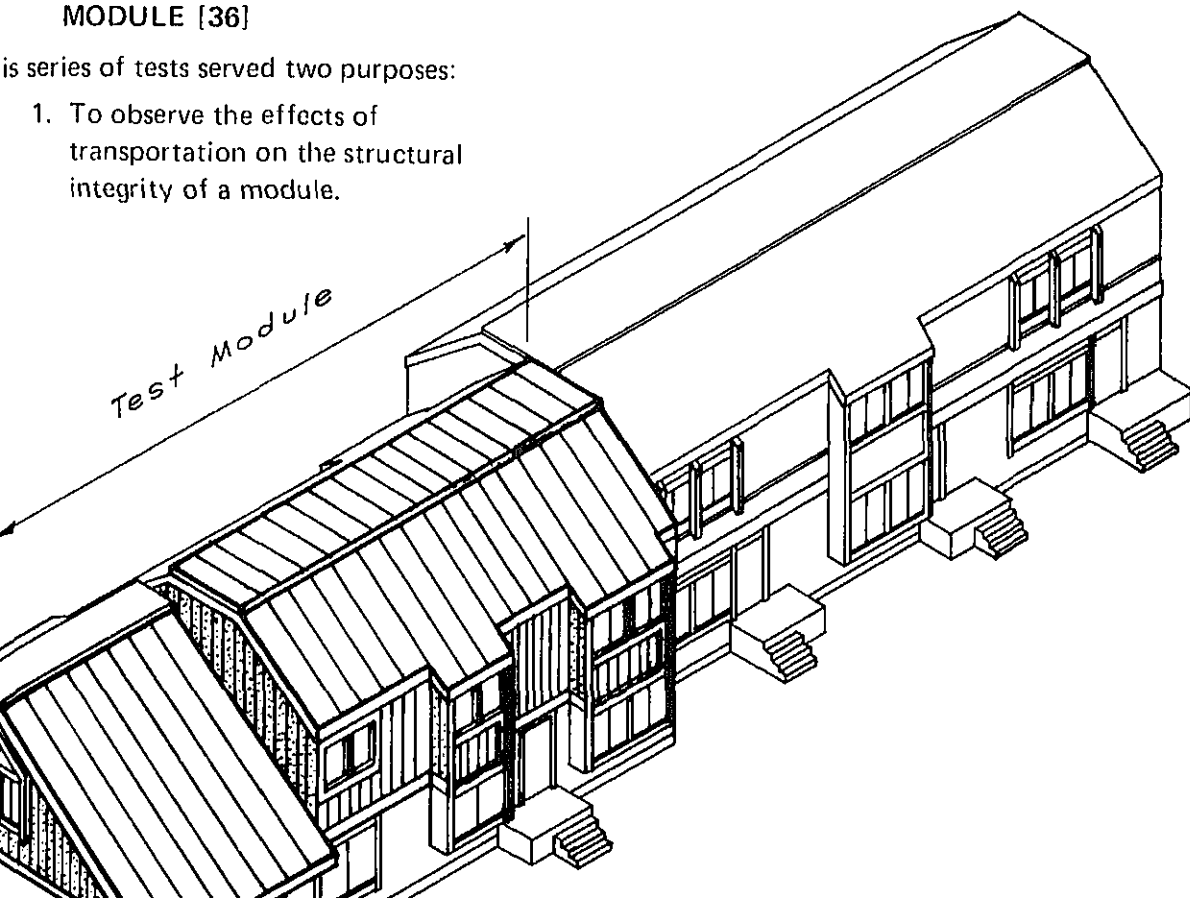
The module chosen for study was part of a building system in many ways similar to conventional construction with wood joists, studs, rafters, sills, plates, plywood roofs and floors, gypsum board wall surfaces, etc. (An extended description can be found in Reference 36.) The test module formed the upper story of the front section of a row housing cluster constructed from several similar modules. (See fig. 44.) The left hand portion of the module was triangular in cross section, served as the

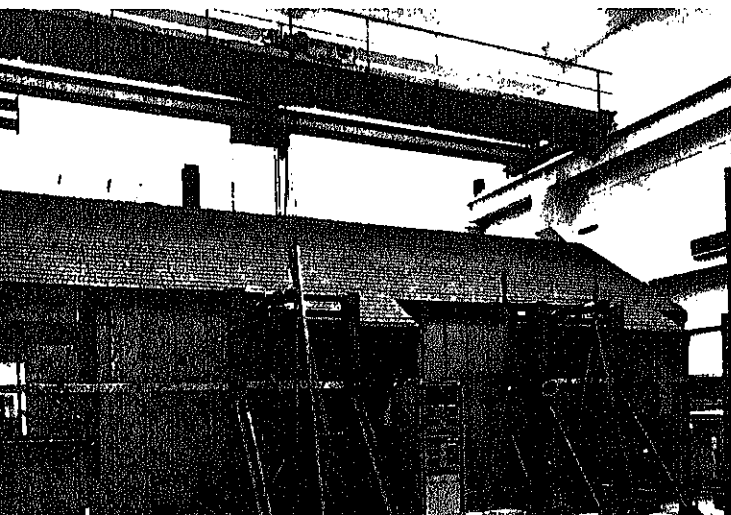
FIGURE 46
LABORATORY SET UP
FOR APPLYING RACKING
LOADS TO
HSP-200-1750 MODULE

The series of tests was very valuable in that it gave an unusual opportunity to investigate several properties of a large structural component that could not be studied adequately by mathematical analysis. The results indicated that the design of the module was adequate with respect to the factors investigated.

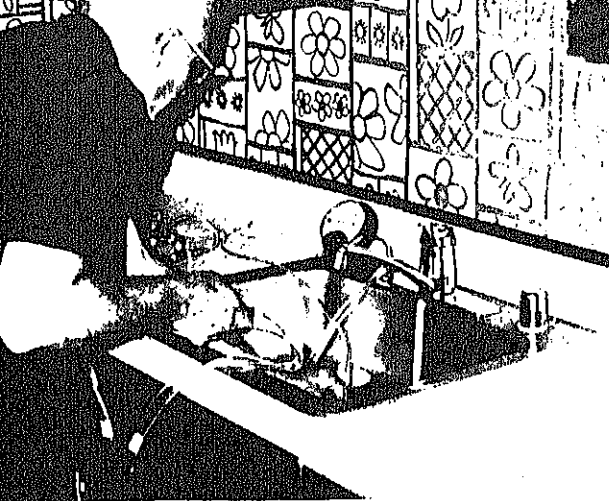
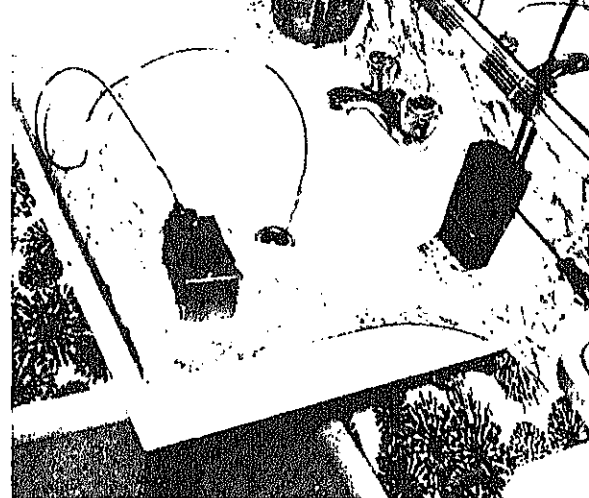
FIGURE 57

TESTING FLOW IN A SINGLE STACK DWV SYSTEM. LEFT, MAKING MEASUREMENTS OF TRAP SEAL DEPTH IN A KITCHEN SINK USING A PNEUMATIC TECHNIQUE; ELECTRONIC MEASUREMENTS COULD NOT BE USED BECAUSE OF A FOOD DISPOSER. RIGHT, USING AN ELECTRONIC TRAP SEAL LEVEL DETECTOR. BOTH METHODS ARE NON-DESTRUCTIVE.

The tests indicated that the single stack DWV system complied with the Guide Criteria with the exception of cross flow. It was additionally concluded that the small amount of cross flow observed was due to faulty installation of the branch piping.

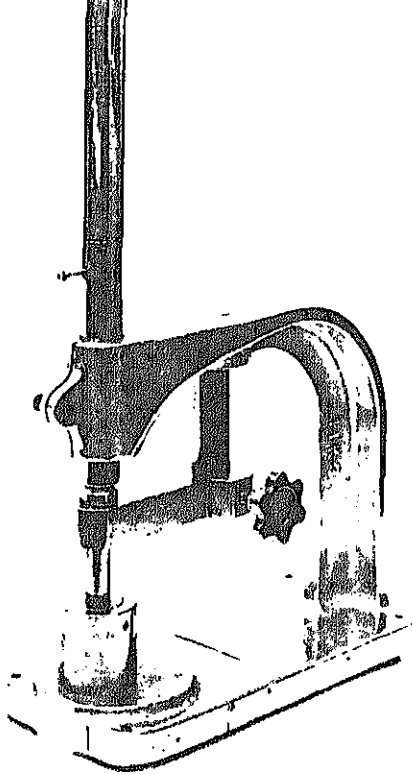
FIGURE 59
PAINT IMPACT TESTER

The impact resistance test provided a measure of the ability of a coating to maintain its integrity when the film and
